**Flood Control Project Maintenance
Levee Inspections**

Fall 2012 Levee Maintenance Deficiency Summary Report

San Joaquin River Basin

Reclamation District No. 2101 Blewett

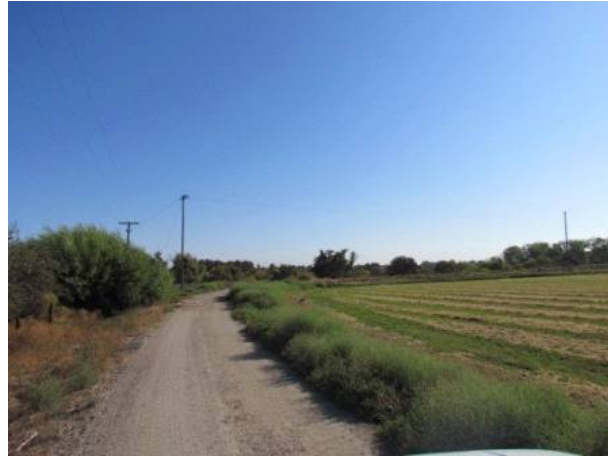
Levee Mile Report Line	4
Start Levee Mile	0.00
End Levee Mile	0.06
Location	Land Side
Category	Earthen Levee
Item	Vegetation

View of tumbleweeds on landside slope obstructing visibility.

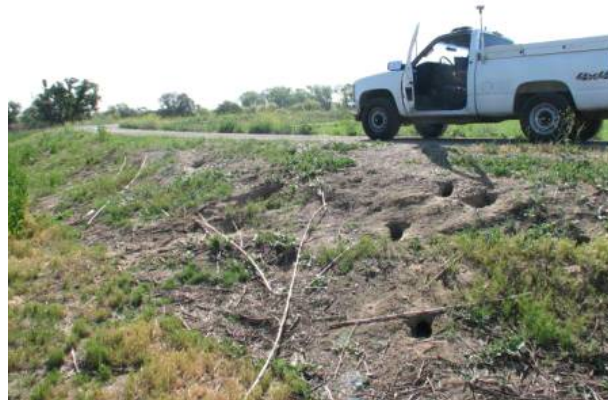
Levee Mile Report Line	5
Start Levee Mile	0.04
End Levee Mile	0.04
Location	Water Side
Category	Earthen Levee
Item	Animal Control

View of rodent holes on waterward slope, facing upstream.

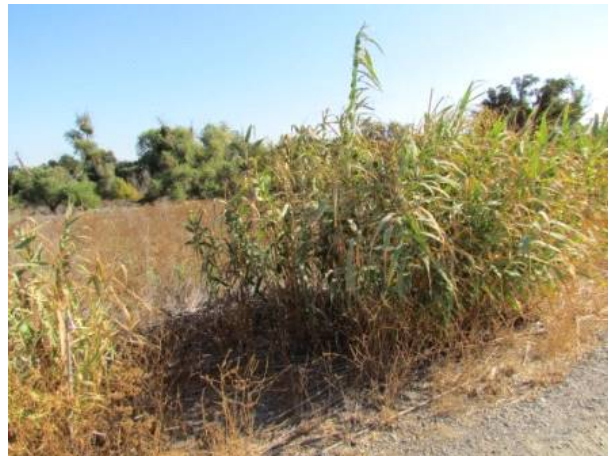
Levee Mile Report Line	6
Start Levee Mile	0.06
End Levee Mile	0.06
Location	Water Side
Category	Earthen Levee
Item	Vegetation

View of Arundo patch on waterside slope near crown obstructing visibility.

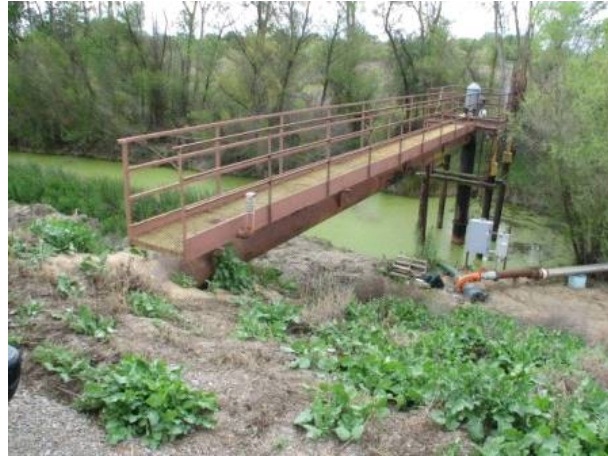
Levee Mile Report Line	8
Start Levee Mile	0.19
End Levee Mile	0.19
Location	Crown
Category	Earthen Levee
Item	Encroachments

Drainage discharge under levee crown.

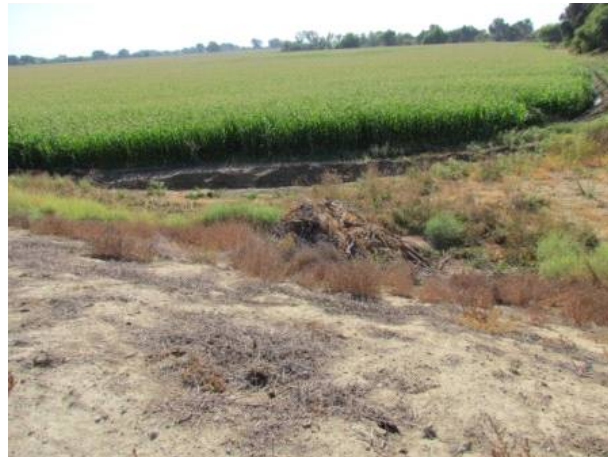
Levee Mile Report Line	10
Start Levee Mile	0.34
End Levee Mile	0.34
Location	Land Side
Category	Earthen Levee
Item	Encroachments

View of pile of prunings at landside levee toe.

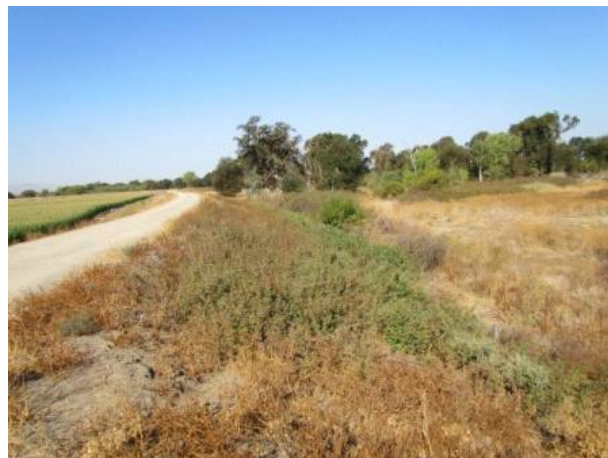
Levee Mile Report Line	11
Start Levee Mile	0.72
End Levee Mile	0.72
Location	Water Side
Category	Earthen Levee
Item	Vegetation

View of wild rose on waterside slope obstructing visibility.

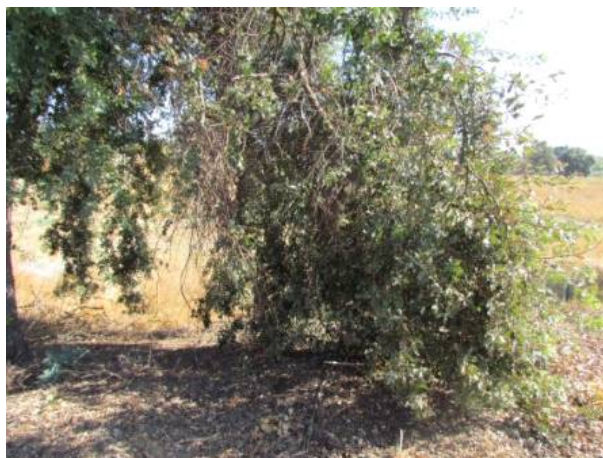
Levee Mile Report Line	12
Start Levee Mile	0.75
End Levee Mile	0.75
Location	Water Side
Category	Earthen Levee
Item	Trim / Thin Trees

View of tree branches obstructing waterside slope.

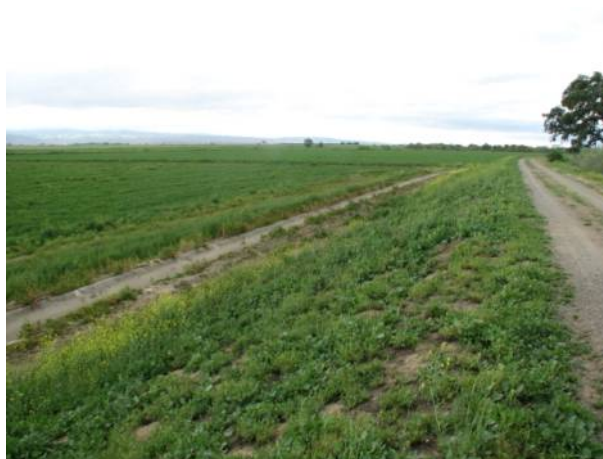
Levee Mile Report Line	13
Start Levee Mile	0.76
End Levee Mile	1.80
Location	Land Side
Category	Earthen Levee
Item	Encroachments

Concrete ditch near landside toe.

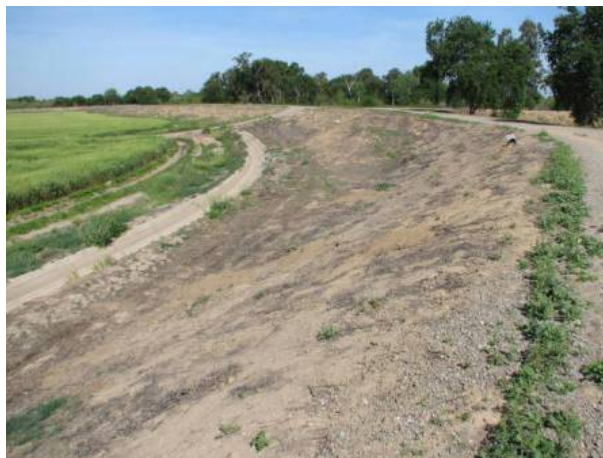
Levee Mile Report Line	14
Start Levee Mile	0.80
End Levee Mile	0.80
Location	Land Side
Category	Earthen Levee
Item	Animal Control

View of levee material removed by rodent activity on landside slope facing downstream. 05/02/2012

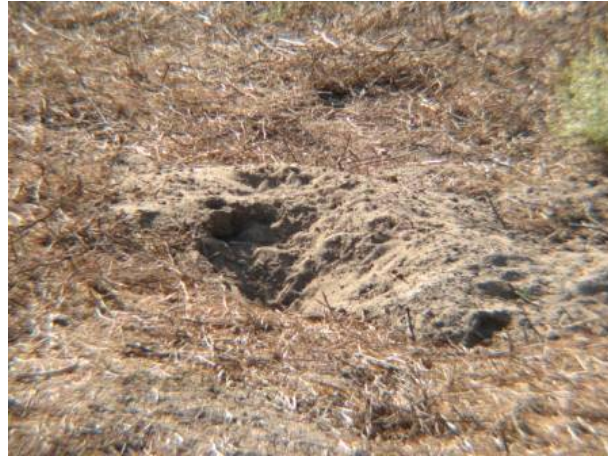
Levee Mile Report Line	15
Start Levee Mile	0.88
End Levee Mile	0.88
Location	Land Side
Category	Earthen Levee
Item	Animal Control
11/02/2011 Active rodent burrow.	
mkhashch_f_20120925_005.jpg

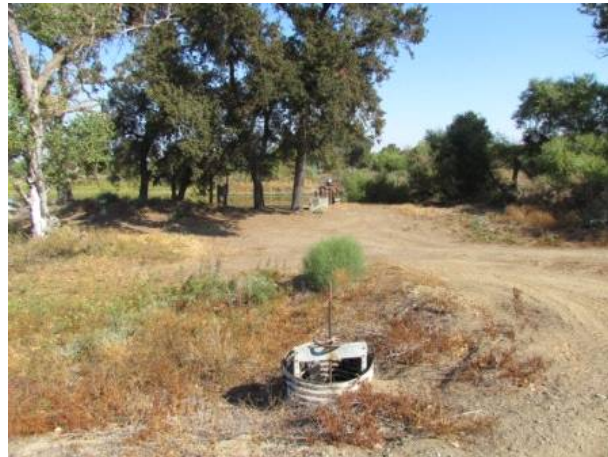
Levee Mile Report Line	17
Start Levee Mile	1.61
End Levee Mile	1.61
Location	Water Side
Category	Earthen Levee
Item	Encroachments
Photo of pump in background and CMP riser with valve in foreground.	
mkhashch_f_20120927_032.JPG

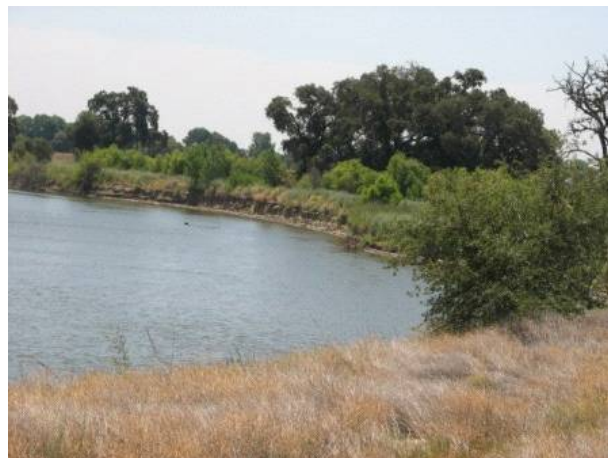
DWR ID: DWR_RD2101_01_s_2012_14										
19	1.91	2.00	Supplemental	DWR Erosion Survey	WS	U Ma	Inspector Comments: 07/18/2012: Erosion has further developed toward levee crown. Vegetation has been removed. 08/18/2011: Erosion progressed significantly during the past flood season. The levee toe along the erosion site was washed away, and the erosion has cut the levee structure up to the point about 1/3 of the levee slope. The scarp height is approximately 17 feet. Very dense vegetation on the site. Trees visible. 10/19/2010: No significant changes observed on site. Remaining levee berm topsoil is of silty sand mixture. Erosion is near the downstream transition. An eddy has formed, and has scoured away a 100-foot section of the bank, possibly encroaching into the levee prism. Vegetation on site includes willows, oak, and cotton wood located from the bench to the toe. On the landside are rows of corn crop. 08/05/2010: Recommended for Repair, per CLRO. 2009: Site recommended as annual assessment and monitoring if critical erosion site, per CLRO CES Evaluation 2008 Report; an eddy has formed, eroding bank and intruding into the levee prism; Site # is the same as RM76.3,LM1.89; previously rated "U". 08/30/2007: Recommended for short list of immediate repair sites; silty sand levee material. [2012 Site ID:RD2101U01RM73.92]	37.650259 ° -121.228961 °	37.650259 ° -121.228961 °	1 Y

Levee Mile Report Line	19
Start Levee Mile	1.91
End Levee Mile	2.00
Location	Water Side
Category	Supplemental
Item	DWR Erosion Survey
Looking downstream from levee top. The tree at the water edge is the visible starting point of the erosion.	
SJR2012_RD2101U01RM73.92_1.jpg

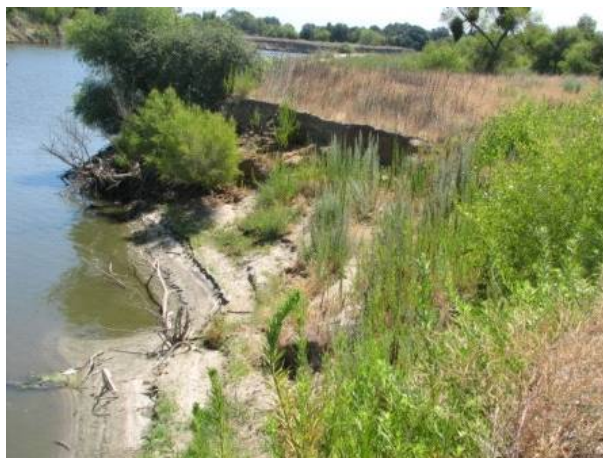
Levee Mile Report Line	19
Start Levee Mile	1.91
End Levee Mile	2.00
Location	Water Side
Category	Supplemental
Item	DWR Erosion Survey

A close look at the erosion.

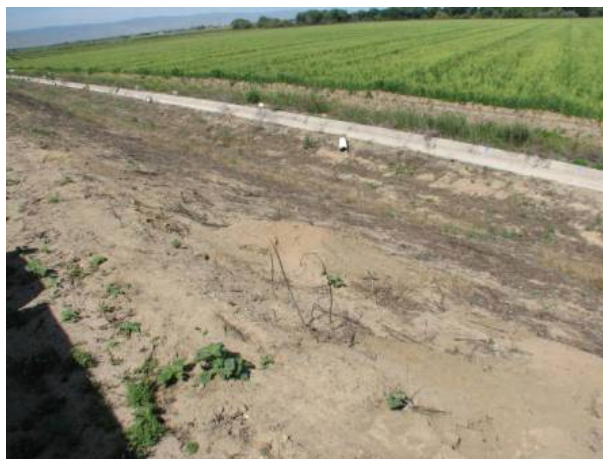
Levee Mile Report Line	20
Start Levee Mile	2.39
End Levee Mile	2.39
Location	Land Side
Category	Earthen Levee
Item	Animal Control

View of levee material removed by rodent activity on landside slope, facing upstream. 05/02/2012

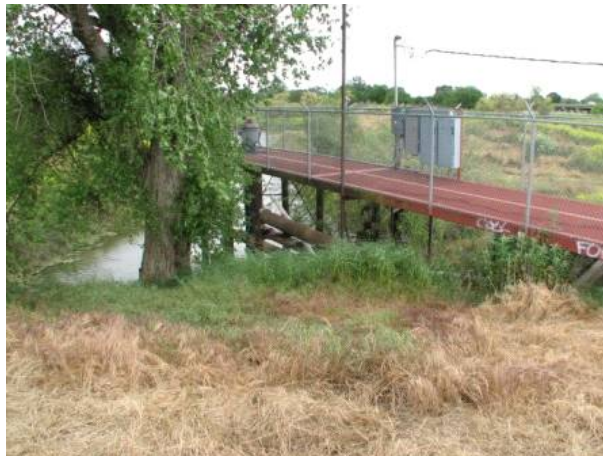
Levee Mile Report Line	21
Start Levee Mile	2.74
End Levee Mile	2.74
Location	Water Side
Category	Earthen Levee
Item	Encroachments

Irrigation intake near Maze Blvd.

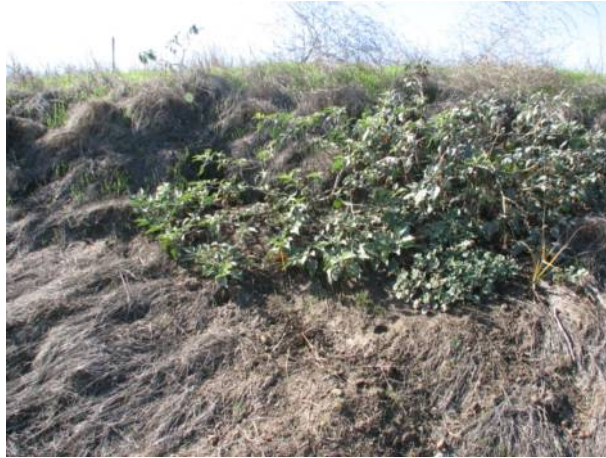
Levee Mile Report Line	22
Start Levee Mile	2.88
End Levee Mile	2.88
Location	Water Side
Category	Earthen Levee
Item	Animal Control

Rodent holes on levee slope hidden by vegetation.

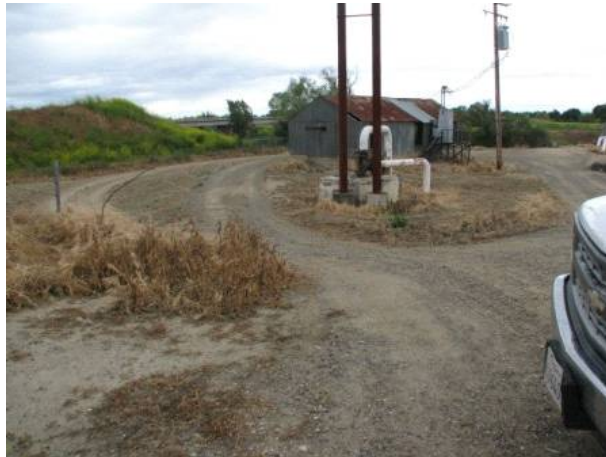
Levee Mile Report Line	23
Start Levee Mile	2.89
End Levee Mile	2.89
Location	Water Side
Category	Earthen Levee
Item	Encroachments

Risers on waterside berm and risers along road leading to levee indicate presence of pipe penetration.

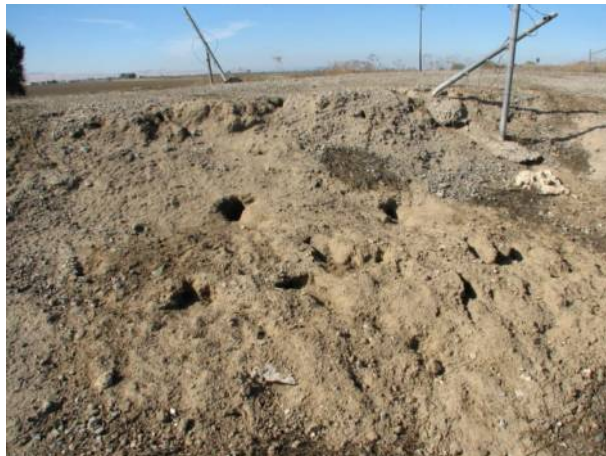
Levee Mile Report Line	24
Start Levee Mile	2.89
End Levee Mile	2.89
Location	Land Side
Category	Earthen Levee
Item	Animal Control

Rodent holes on levee slope.

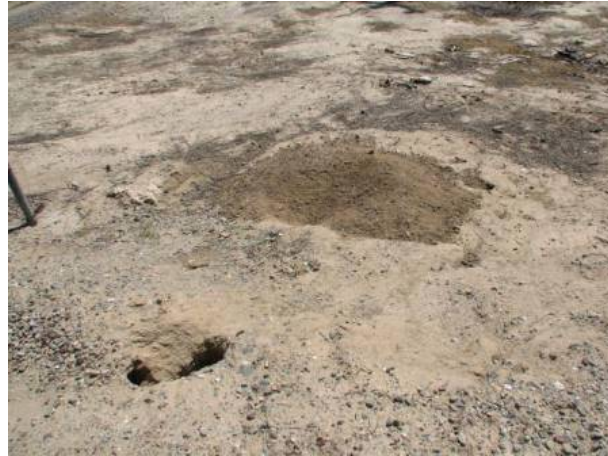
Levee Mile Report Line	24
Start Levee Mile	2.89
End Levee Mile	2.89
Location	Land Side
Category	Earthen Levee
Item	Animal Control

05/26/2011 Updated photo of animal control issue noted in Fall 2010 inspection, fresh rodent burrow present.

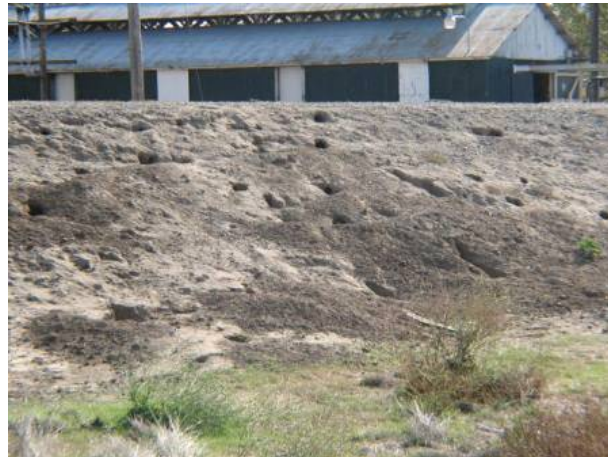
Levee Mile Report Line	24
Start Levee Mile	2.89
End Levee Mile	2.89
Location	Land Side
Category	Earthen Levee
Item	Animal Control

11/02/2011 Numerous burrows on levee slope.

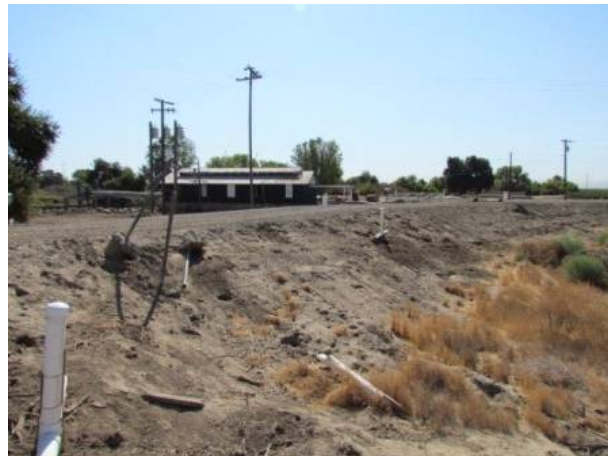
Levee Mile Report Line	24
Start Levee Mile	2.89
End Levee Mile	2.89
Location	Land Side
Category	Earthen Levee
Item	Animal Control

View of numerous rodent holes with bait stations present. 09/25/2012

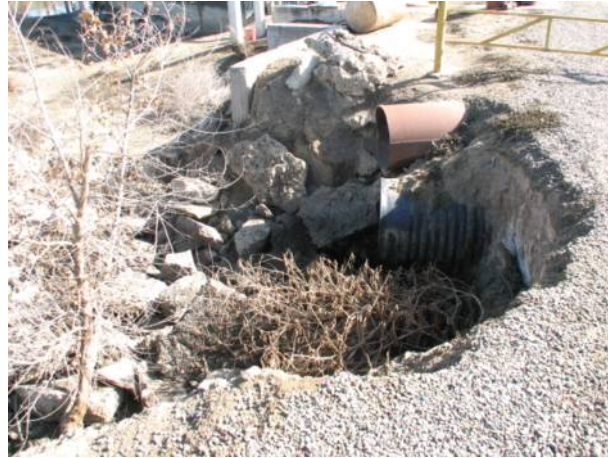
Levee Mile Report Line	25
Start Levee Mile	2.91
End Levee Mile	2.91
Location	Water Side
Category	Earthen Levee
Item	Erosion / Bank Caving

Levee slope is being eroded at this location. Repair needed to preserve access road.

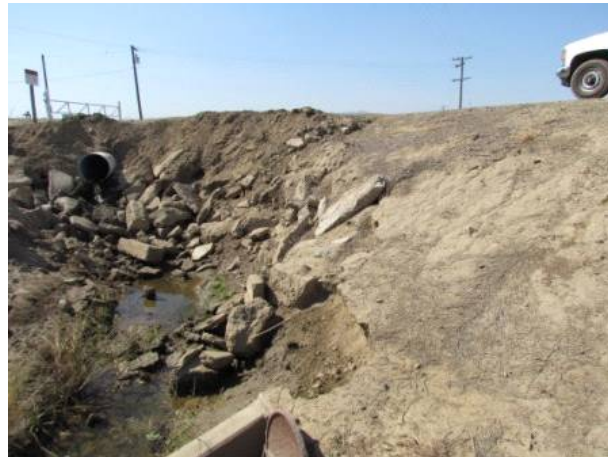
Levee Mile Report Line	25
Start Levee Mile	2.91
End Levee Mile	2.91
Location	Water Side
Category	Earthen Levee
Item	Erosion / Bank Caving

View of repaired site, but it appears that erosion is still occurring. 09/25/2012

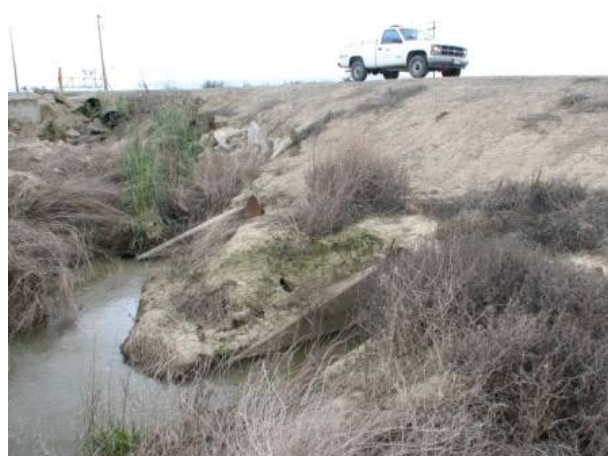
Levee Mile Report Line	26
Start Levee Mile	2.91
End Levee Mile	2.91
Location	Water Side
Category	Earthen Levee
Item	Encroachments

Drainage discharge to San Joaquin River.

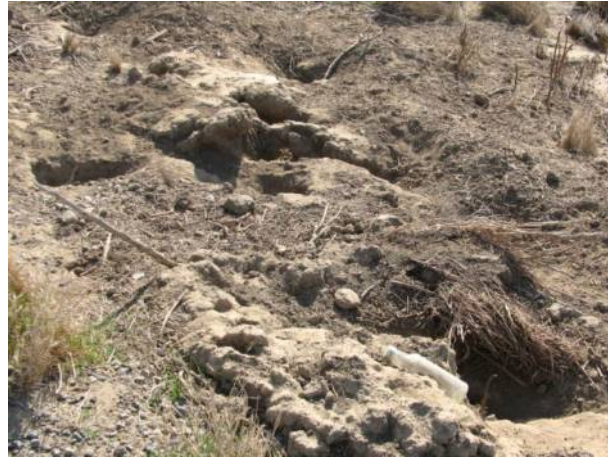
Levee Mile Report Line	27
Start Levee Mile	3.02
End Levee Mile	3.20
Location	Land Side
Category	Earthen Levee
Item	Animal Control
11/02/2011 Numerous burrows present, some already caving in, others are active.	
mkhashch_f_20120925_009.jpg

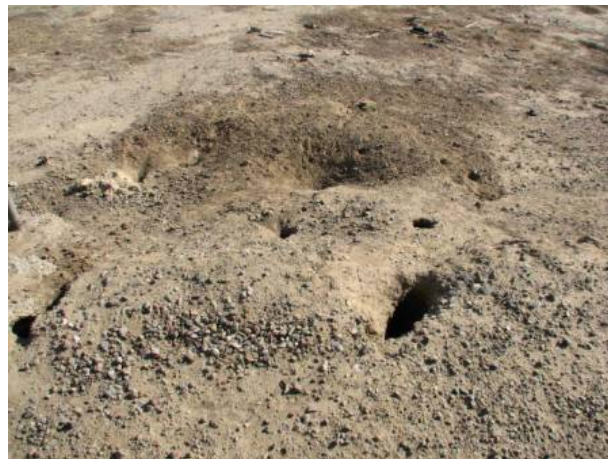
Levee Mile Report Line	27
Start Levee Mile	3.02
End Levee Mile	3.20
Location	Land Side
Category	Earthen Levee
Item	Animal Control
11/02/2011 Many active burrows present.	
mkhashch_f_20120925_010.jpg

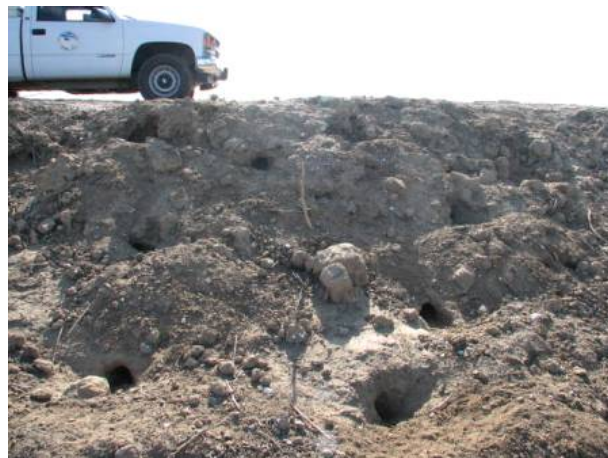
Levee Mile Report Line	27
Start Levee Mile	3.02
End Levee Mile	3.20
Location	Land Side
Category	Earthen Levee
Item	Animal Control
11/02/2011 Many burrows present throughout the levee slope.	
mkhashch_f_20120925_011.jpg

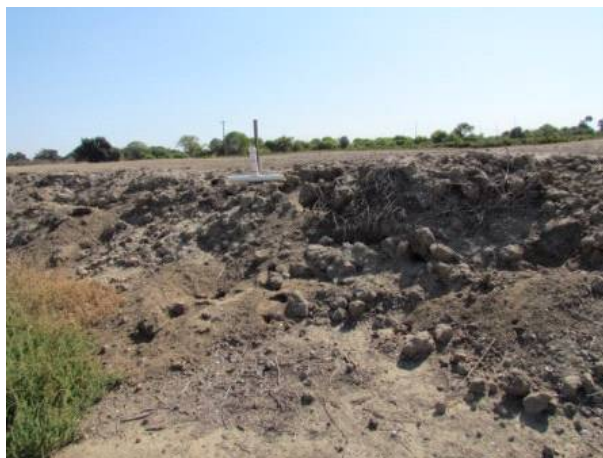
Levee Mile Report Line	27
Start Levee Mile	3.02
End Levee Mile	3.20
Location	Land Side
Category	Earthen Levee
Item	Animal Control

View of the many rodent holes on landside slope.
09/25/2012

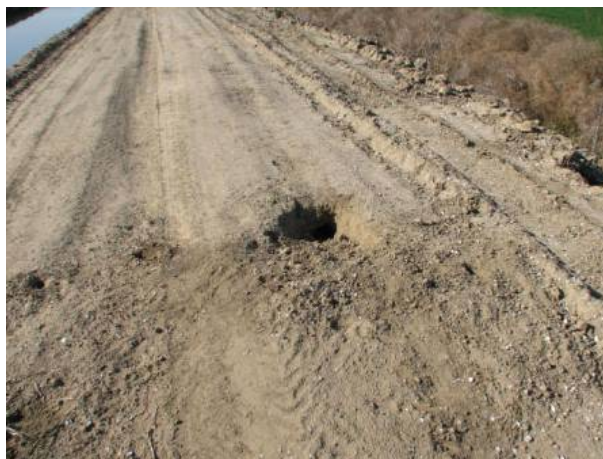
Levee Mile Report Line	28
Start Levee Mile	3.11
End Levee Mile	3.11
Location	Crown
Category	Earthen Levee
Item	Animal Control

11/02/2011 Large burrow in crown.

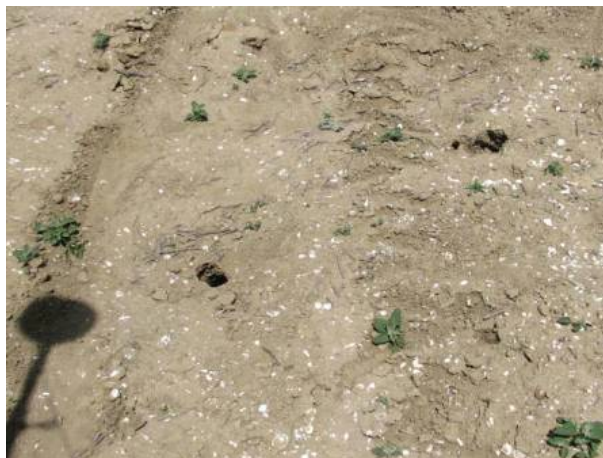
Levee Mile Report Line	28
Start Levee Mile	3.11
End Levee Mile	3.11
Location	Crown
Category	Earthen Levee
Item	Animal Control

05/02/2012 Rodent holes in the levee crown.

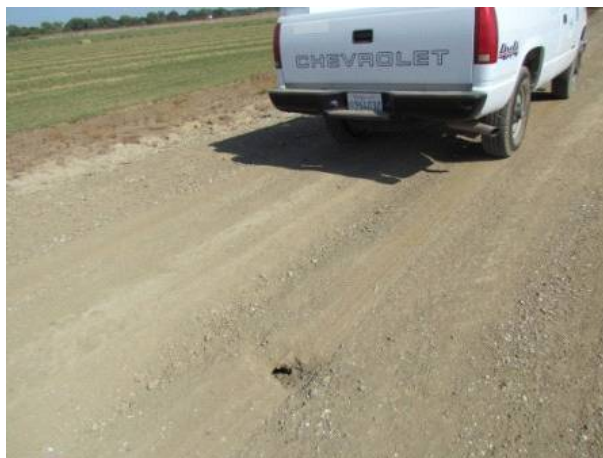
Levee Mile Report Line	28
Start Levee Mile	3.11
End Levee Mile	3.11
Location	Crown
Category	Earthen Levee
Item	Animal Control

View of the rodent hole in the levee crown.
Smaller holes were covered due to crown
regrading. 09/25/2012

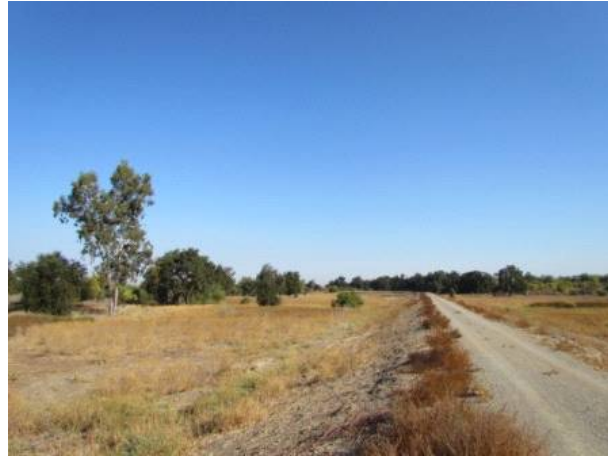
View of acceptable vegetation control on waterside slope.

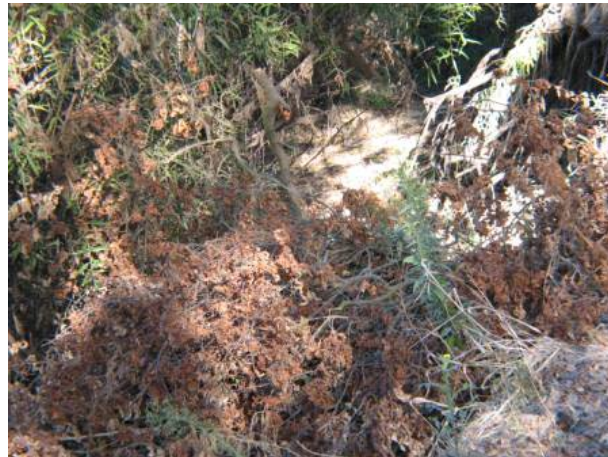
Levee Mile Report Line	2
Start Levee Mile	0.31
End Levee Mile	0.31
Location	Water Side
Category	Earthen Levee
Item	Erosion / Bank Caving

11/02/2011 Updated photo of the scouring occurring at the end of the spur levee.
